STENMAR Group

Hydraulic Upgrade

Stenmar Group were contracted to do major hydraulic upgrade work at a large poultry processing plant in Melbourne.

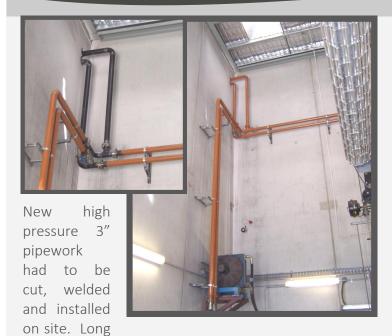
A new power unit was commissioned in a dedicated plant room. Existing pipework had to be tapped into. The old power unit was then disconnected and re-located to the plant room alongside the new unit. A 5" stainless steel balance pipe was installed between the two.

Flanged stainless steel ball valves were fitted to allow isolation where required.

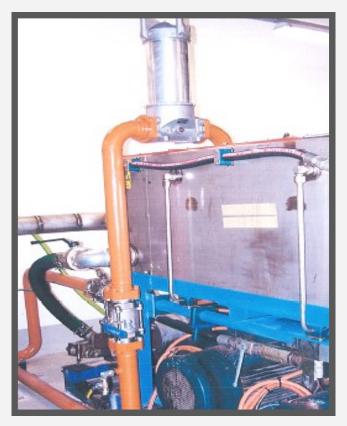
New filtration was installed to provide suitable protection from contaminants for the expanded hydraulic system.

A heat exchanger circuit was also added to cool operating temperatures. This was assembled on a specially built skid/frame and mounted on the roof of the building.

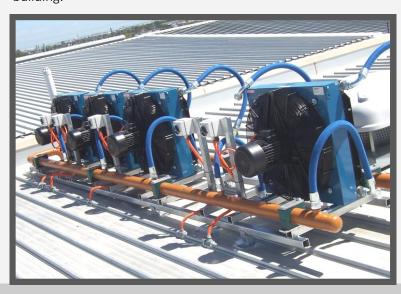
Additional pipework to the rooftop was required to allow the incorporation of the bank of heat exchangers.
