Hydraulic Support Services

Machine Overhaul

STENMAR Group

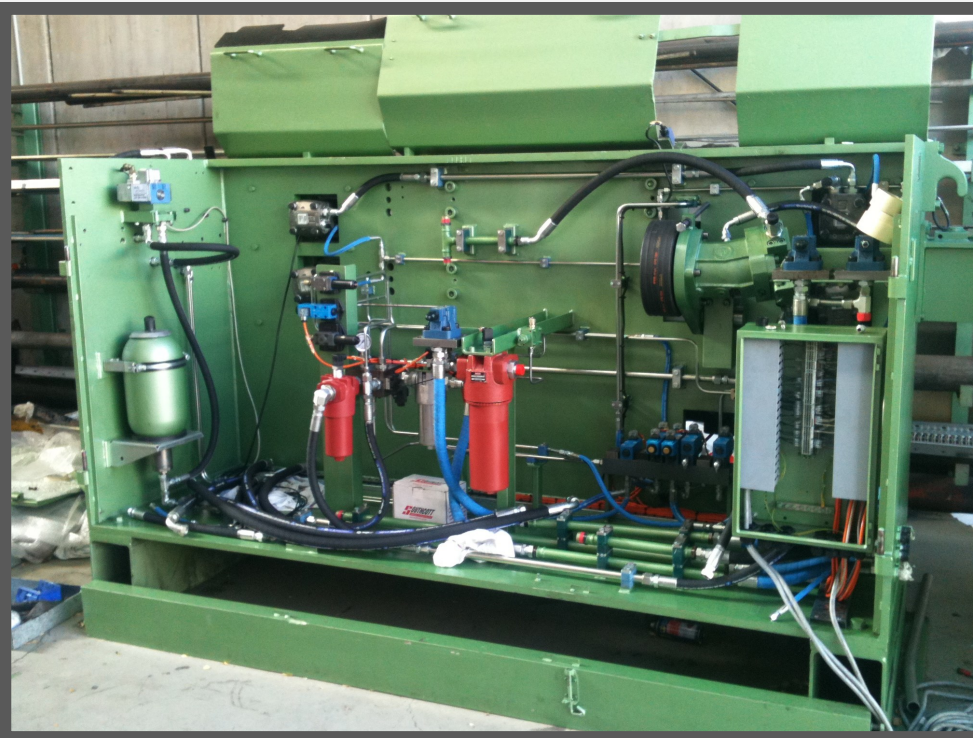
Stenmar Group stripped the machine and disassembled all the components. There were 6 hydraulic motors, 2 pumps, 2 accumulators, various filters & accessories, an electrical cabinet, and an assortment of valves, brackets, tubes and hoses. All needed to be inspected and assessed. Most required repair or replacement. Many of the mechanical items on the machine were also very worn.

Everything first had to be cleaned (a *major* undertaking). Items that could be repaired were completely refurbished and tested. Then began the painting, mounting, piping, hosing, wiring and labeling. The configuration of the machine was altered to allow better access for inspection and maintenance. Consideration was also given to improv-

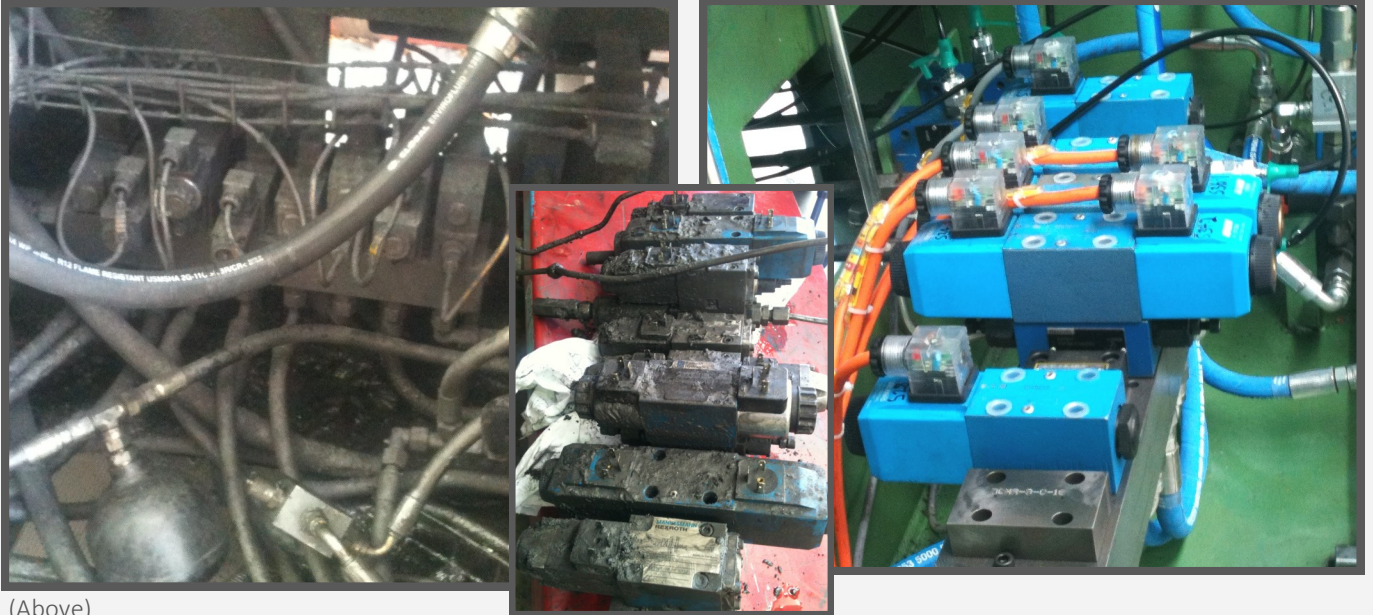
(Above)

The directional control valve manifold was a sludge encrusted mess in a spaghetti jungle of hoses and wiring when it arrived at Stenmar. The finished valve bank was neatly mounted, wired, labeled and hosed.

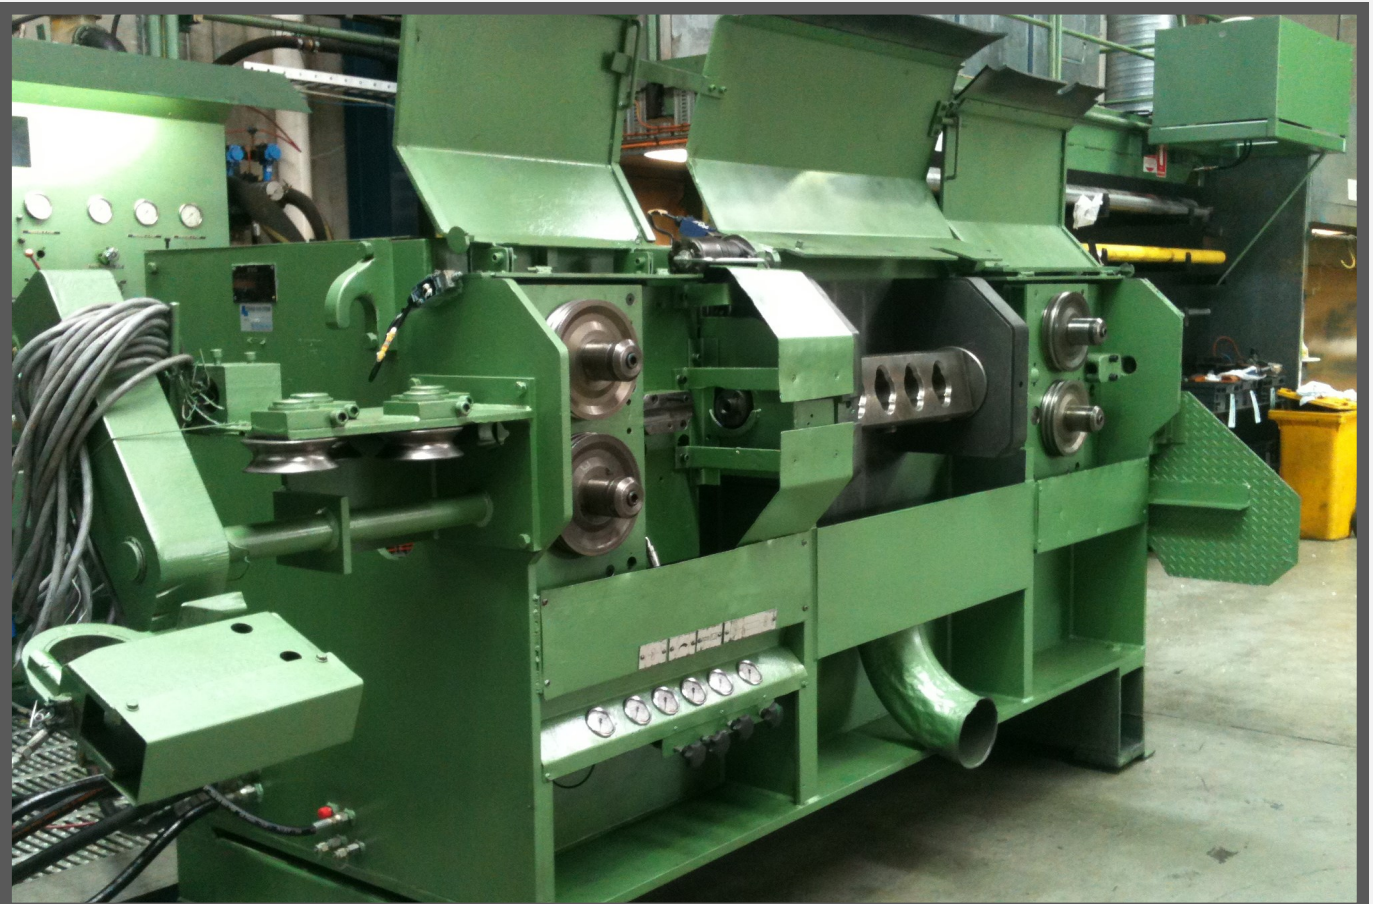
The refurbished machine undergoing final testing.

ing the operating specifications for oil temperature and cleanliness. A new hydraulic circuit drawing of the updated machine was prepared in AutoCAD and all components were test-run in-house before the whole unit was returned to the customer's factory for on site commissioning.
